CONTROL OF ASBESTOS REGULATIONS 2006

S1366, KILBRANNAN HOUSE, CAMPBELTOWN, ASBESTOS SURVEY

Inspection Dates: 22ND September 2004

Site Address: Kilbrannan House, Bolgarn Street, Campbeltown

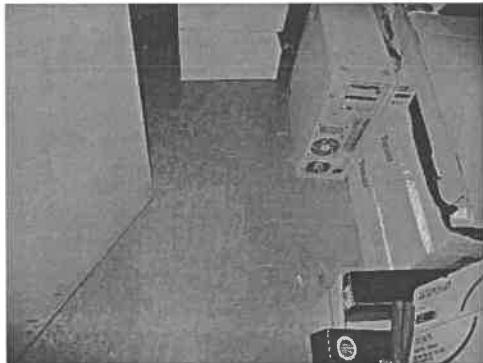
Photo 1

Asbestos Survey Record - No. MW220904S009

Product Type	N/A
Damage/Deterioration	N/A
Surface Treatment	N/A
Asbestos Type	N/A
Total:	
Risk Evaluation:	
Vulnerability:

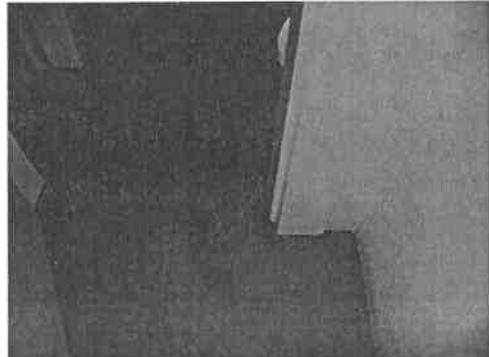
Photo 1

Asbestos Survey Record - No. MW220904S010

Product Type	N/A	1-3
Damage/Deterioration	N/A	0-3
Surface Treatment	N/A	0-3
Asbestos Type	N/A	0-3
Total:	N/A	
Risk Evaluation:	N/A	
Vulnerability:	N/A

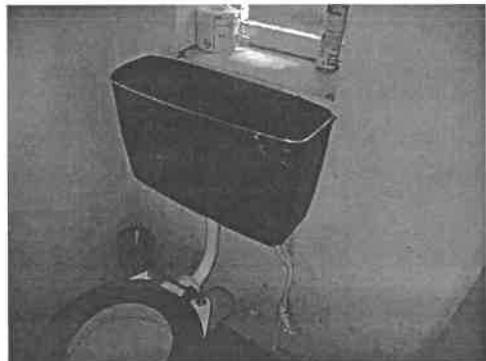
Photo 1

Asbestos Survey Record - No. MW220904V011

Product Type	Plastic	1	1-3
Damage/Deterioration	Good Condition	0	0-3
Surface Treatment	Reinforced composite material	0	0-3
Asbestos Type	Amosite	2	0-3

Vulnerability: Easy

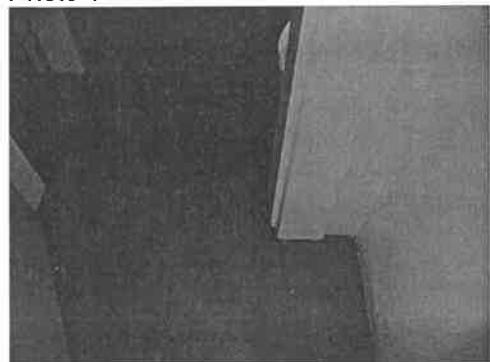
Photo 1

Asbestos Survey Record - No. MW220904V012

<u>Score</u>	<u>Range</u>
Product Type	NA	1-3
Damage/Deterioration	NA	0-3
Surface Treatment	NA	0-3
Asbestos Type	NA	0-3
Total:	NA	
Risk Evaluation:	NA	
Vulnerability:	NA

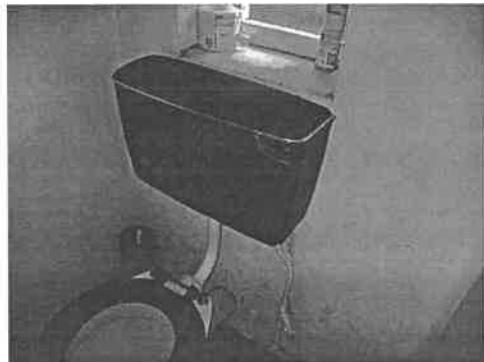
Photo 1

Asbestos Survey Record - No. MW220904V013

<u>Material Assessment</u>		<u>Score</u>	<u>Range</u>
Product Type	Plastic	1	1-3
Damage/Deterioration	Good Condition	0	0-3
Surface Treatment	Reinforced composite material	0	0-3
Asbestos Type	Amosite	2	0-3
Total:		3

Vulnerability: Easy

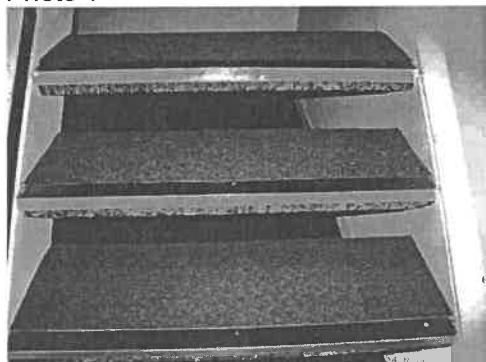
Photo 1

Asbestos Survey Record - No. MW220904S014

Product Type	Plastic	1	1-3
Damage/Deterioration	Good Condition	0	0-3
Surface Treatment	Reinforced composite material	0	0-3
Asbestos Type	Chrysotile	1	0-3

Vulnerability: Easy

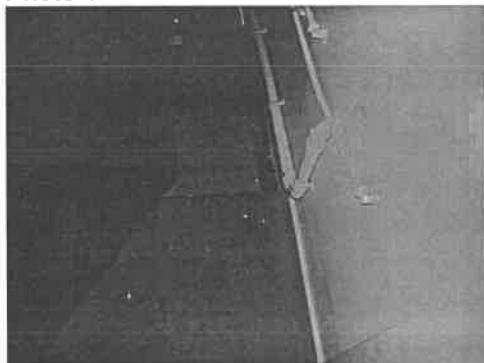
Photo 1

Asbestos Survey Record - No. MW220904S015

Product Type	N/A	1-3
Damage/Deterioration	N/A	0-3
Surface Treatment	N/A	0-3
Asbestos Type	N/A	0-3
Total:	N/A	
Risk Evaluation:	N/A	
Vulnerability:	N/A

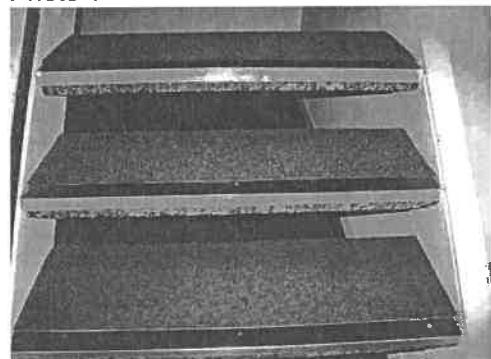
Photo 1

Asbestos Survey Record - No. MW220904V016

<u>Score</u>	<u>Range</u>
Product Type	Plastic	1	1-3
Damage/Deterioration	Good Condition	0	0-3
Surface Treatment	Reinforced composite material	0	0-3
Asbestos Type	Chrysotile	1	0-3

Vulnerability: Easy

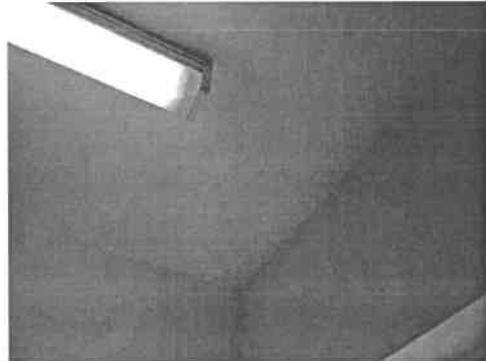
Photo 1

Asbestos Survey Record - No. MW220904S017

Product Type	Insulating Boa
Damage/Deterioration	Good Condition
Surface Treatment	Painted/encap
Asbestos Type	Amosite

Vulnerability: Medium

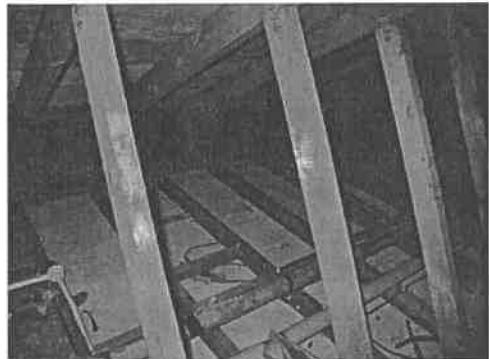
Photo 1

Asbestos Survey Record - No. MW220904V018

Product Type	Insulating Board
Damage/Deterioration	Good Condition
Surface Treatment	Unsealed board
Asbestos Type	Amosite

Vulnerability: Difficult

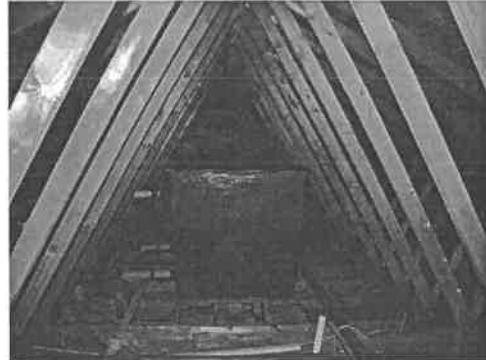
Photo 1

Asbestos Survey Record - No. MW220904V019

No Access

No crawl boards for safe access
